ARMY ENGINEER DISTRICT, PHILADELPHIA PA
FLOOD PLAIN INFORMATION, LITTLE NESHAMINY CREEK, BUCKS COUNTY, --ETC(U)
NOV 73

LEVEL II
FLOOD PLAIN
INFORMATION

LITTLE NESHAMINY CREEK
BUCKS COUNTY, PENNSYLVANIA

PREPARED FOR THE BUCKS COUNTY PLANNING COMMISSION
BY CORPS OF ENGINEERS, U.S. ARMY PHILADELPHIA DISTRICT

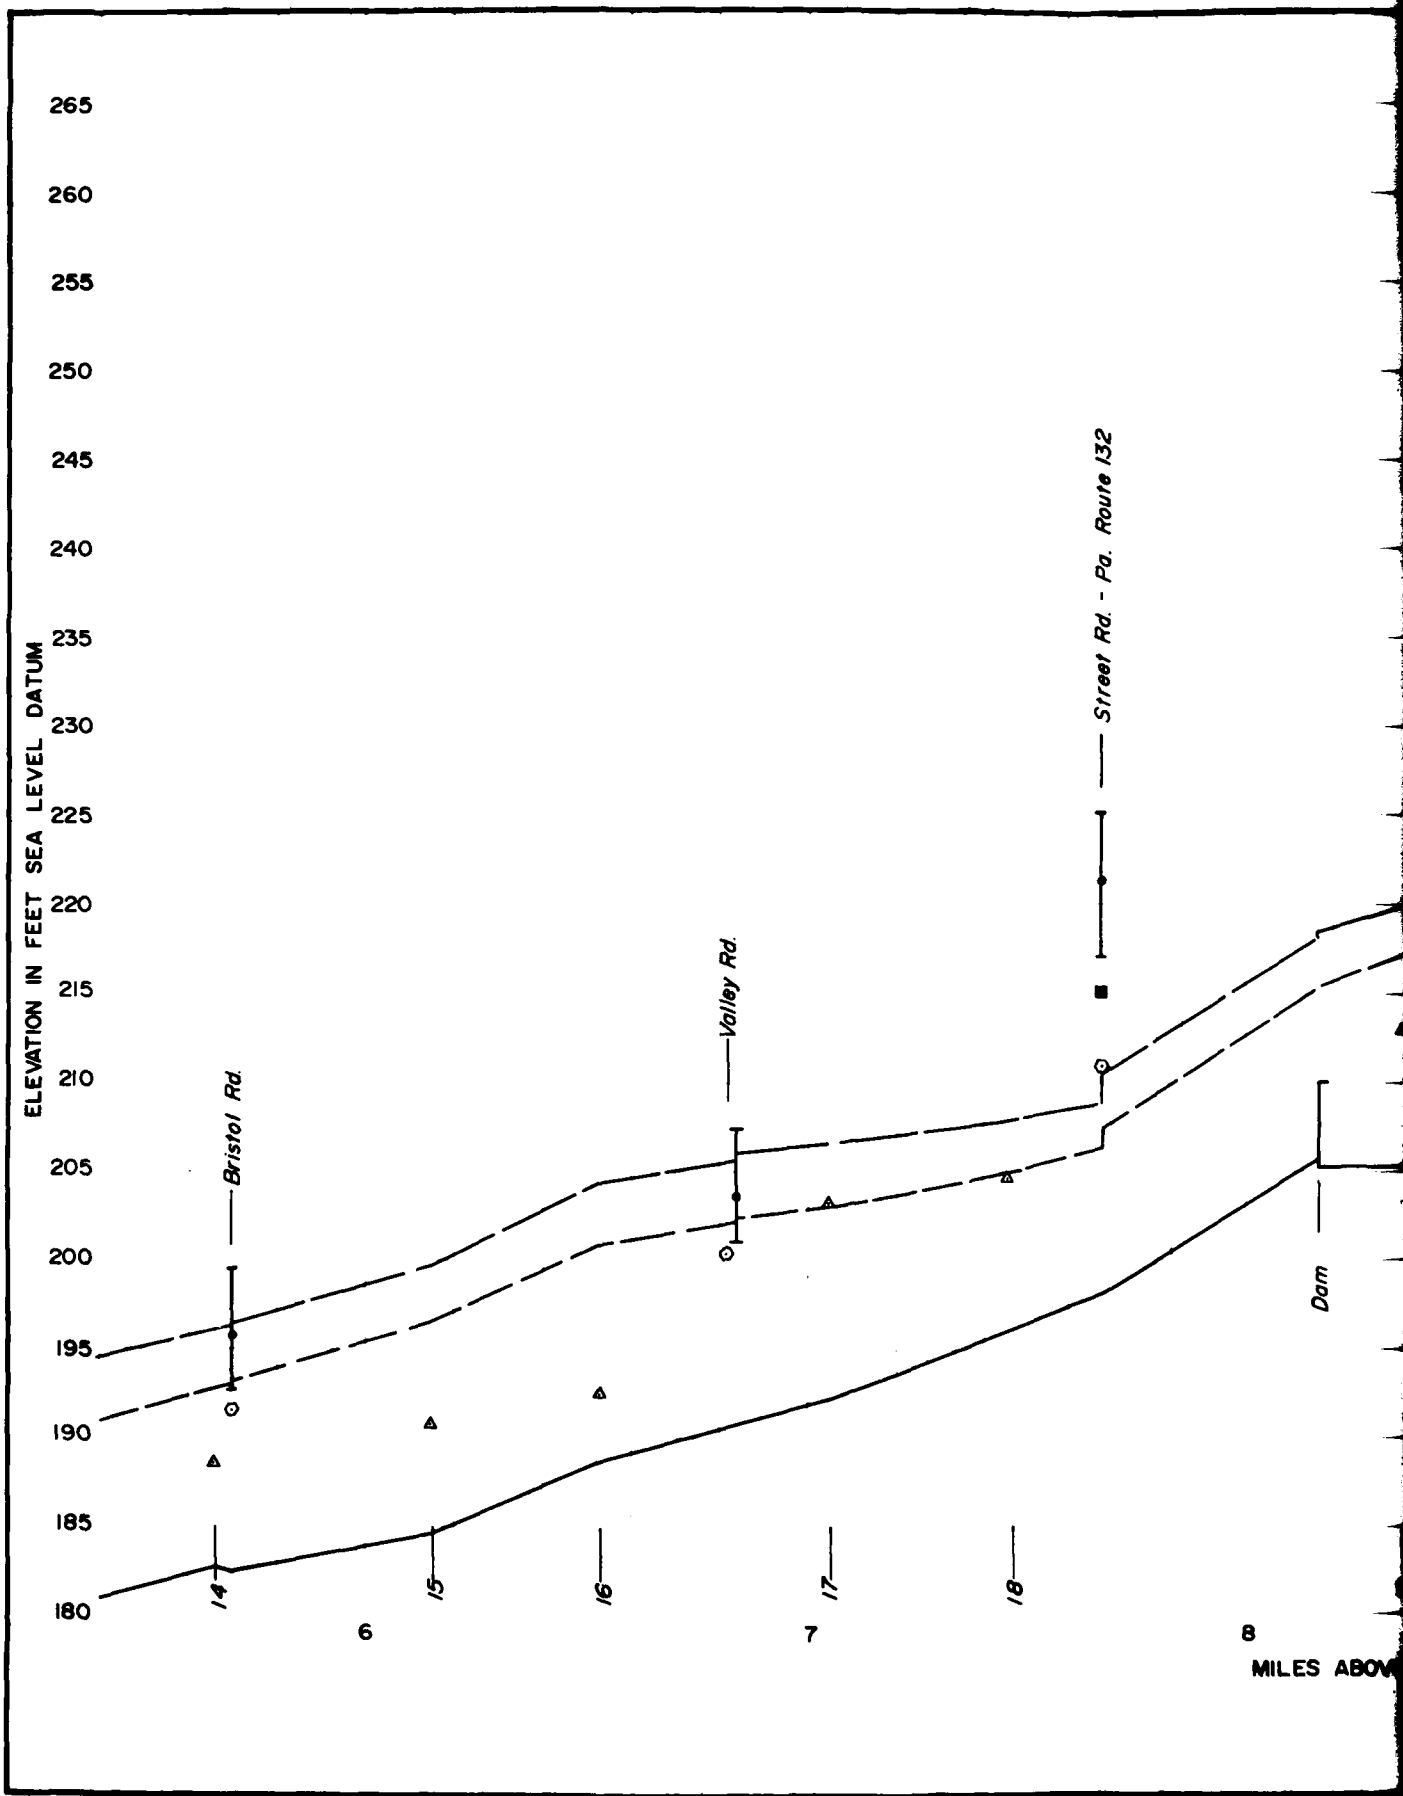
HIGH WATER PROFILES

Since the August 19, 1955 and September 13, 1960 floods, Valley Road, Street Road, and Easton Road bridges have been replaced by structures with larger waterway openings.

At Street Road (Pa. Rte. 132) Bridge, a high water mark was recorded that exceeds the calculated Standard Project Flood elevation. This extremely high elevation was caused by an inadequately sized bridge waterway opening that became clogged by debris. This structure and several others have since been replaced by bridges with much larger opening areas. (See "High Water Profile, Little Neshaminy Creek," Plate 8.)

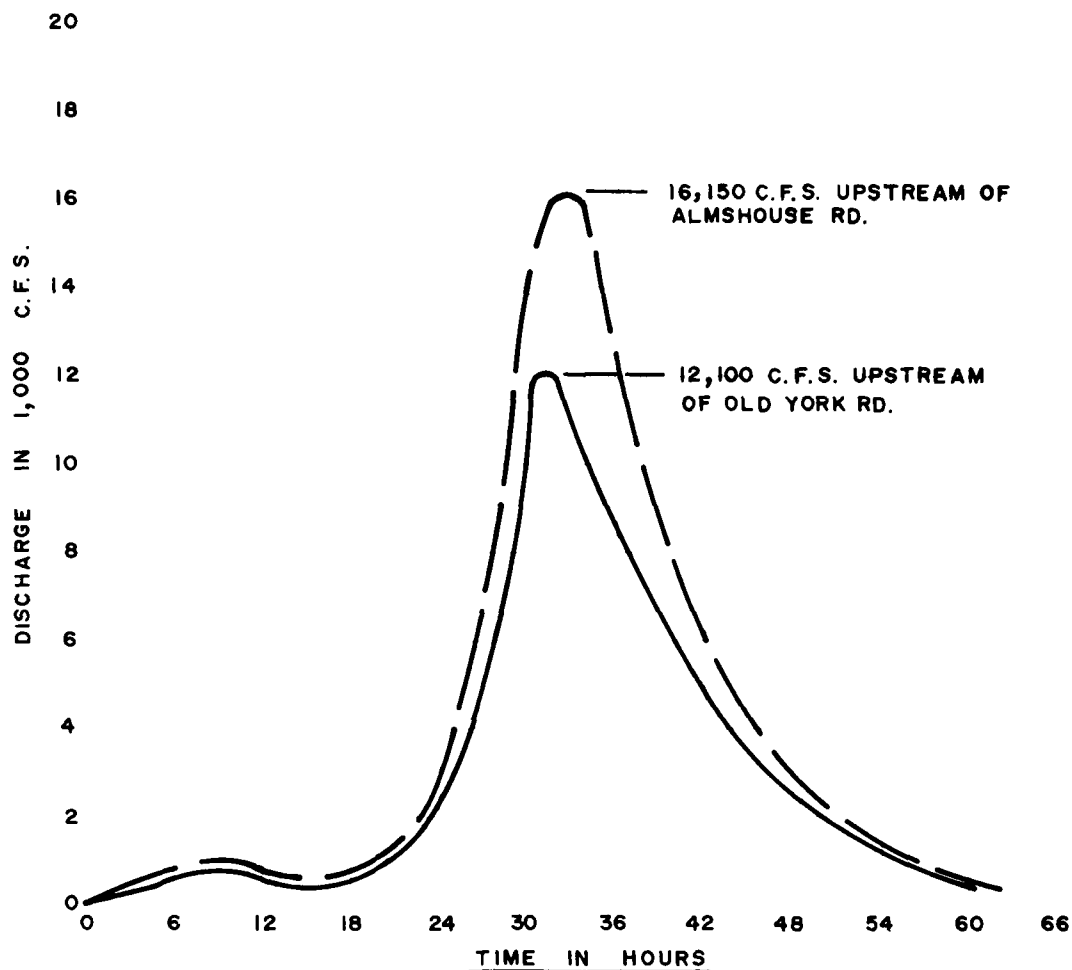
DEPARTMENT OF THE ARMY
 PHILADELPHIA DISTRICT, CORPS OF ENGINEERS
 PHILADELPHIA, PENNSYLVANIA
 FLOOD PLAIN INFORMATION
 LITTLE NESHAMINY CREEK
BUCKS COUNTY, PA.
 STANDARD PROJECT FLOOD
 HYDROGRAPHS

<u>DRAINAGE AREA</u>	<u>SQ. MI.</u>
UPSTREAM ALMSHOUSE RD.	39.5
UPSTREAM OLD YORK RD.	30.1
